MRL-R-1139

DEFENCE SCIENCE AND TECHNOLOGY ORGANISATION

CORROSION OF HIGH-DENSITY SINTERED TUNGSTEN ALLOYS
PART 1: IMMERSION TESTING

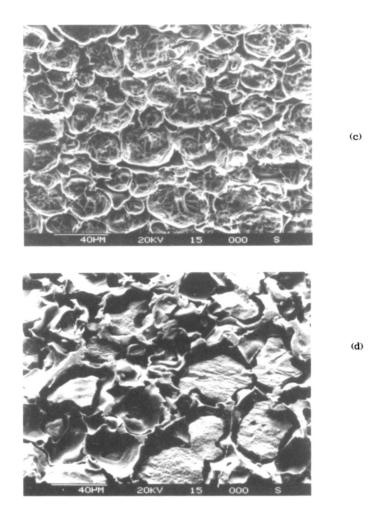
Figure 2 consists of SEM micrographs of the surfaces of tungsten and the four tungsten alloys after full immersion in distilled water for seventy days and after the corrosion products have been removed; the interpretation of these micrographs is given in Table 3. From these it is clear that the mode of attack has varied between the various alloys. For AUS and UK(Fe) the primary tungsten particles have suffered little or no attack but some attack (still slight) is evident on the binder phase. On the other hand, for US and UK(Cu) extensive attack on the tungsten grains and the binder is evident and tungsten grain loss has occurred (i.e. grains cease to be bound).

SEM micrographs of the surfaces of tungsten alloys and tungsten itself after full immersion in distilled water for seventy days and after removal of the corrosion products. FIG. 2

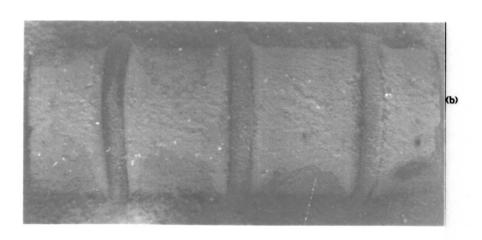
Figures 5 and 6 are photographs of the samples after exposure times of seventy days and twelve months, respectively. Comparison of these with Figure 3 indicates that the corrosion behaviour (except for W) has been dramatically affected by the O-rings. For example, corrosion products have accumulated adjacent to the O-rings for AUS and UK(Fe) and their composition appears to have been affected. Further, for UK(Fe) there now appear to be two, quite distinct, corrosion products on the surface.

FIG. 5 (next page) State of tungsten alloys and tungsten itself after full immersion in 5% sodium chloride solution for seventy days at ambient temperature, in the presence of crevices.

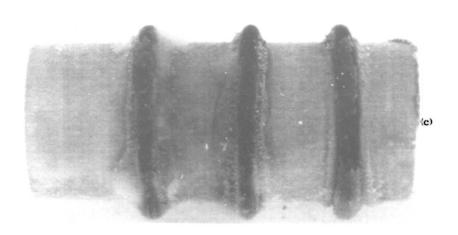
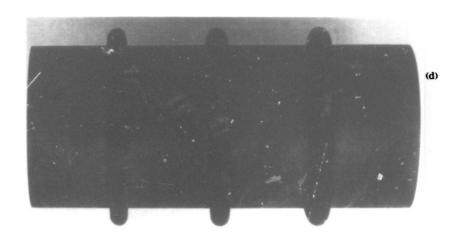
State of tungsten alloys after full immersion in sodium chloride solution for twelve months in the presence of crevices. FIG. 6

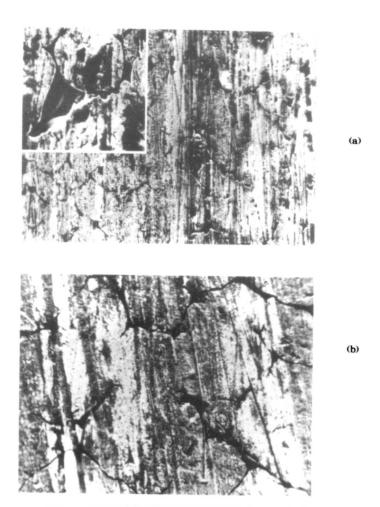
In general, for the two copper-free alloys (AUS, UK(Fe)), the attack has primarily taken place in the area under the O-ring (indicative of differential aeration or crevice type corrosion), while the areas some distance from the O-ring have suffered little attack (this is particularly the case for the primary tungsten grain phase). On the other hand, for the two copper-containing alloys (US, UK(Cu)) the main attack has taken place away from the creviced areas.

Corrosion		Observation After the Test	
	Under O-ring	Inmediately adjacent to O-ring	Away from 0-ring
AUS, 70 day exposure (Pig. 7)	Some polishing marks still evident on tungsten particles, there has been some tungsten surface attack. Binder has been attacked (see inset).	Appears to have been some general attack.	Polishing marks still quite evident. Little attack, if any.
AUS, 12 month exposure (Fig. 8)	Both the surface of the tungsten particles and binder have been severely attacked. Tungsten particles could be standing proud of binder.	Appears to have been some general attack.	Polishing marks still quite evident on tungsten particles, hence little attack. Binder has been attacked.
US 12 month exposure (Fig. 9)	Some polishing marks still evident. Both the surface of the tungsten particles and binder lightly attacked.	Attacked more than under O-ring.	Severe attack on both tungsten particles and the binder.

FIG. 7 SEM micrographs of the surface of the tungsten alloy AUS after full immersion in sodium chloride solution for seventy days in the presence of crevices.

(a)	LHS of micrograph, area under the O-ring; immediately adjacent to O-ring.	RHS, area
(b)	Inset, area under the O-ring.	(x500)
(D)	Area some distance from O-ring.	(x500)

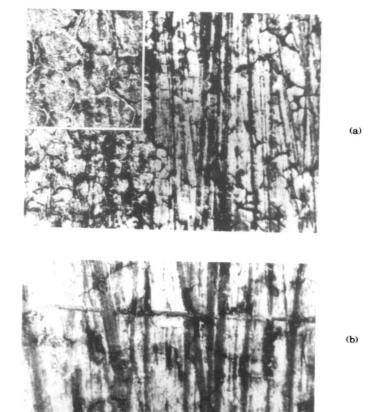
Corrosion		Observation After the Test	
and the same of th	Under O-ring	Immediately adjacent to 0-ring	Away from O-ring
UK(Fe) 12 month exposure (Fig. 10)	Both the surface of the tungsten particles and binder have been severely attacked.	Appears to have been some general attack.	Polishing marks still quite evident on tungsten particles, hence little attack. Binder has been attacked.
UK(Cu) 70 day exposure (Fig. 11)	Polishing marks still evident on tungsten particles and binder. There may have been slight general surface attack.	Some polishing marks are still apparent although attack has occurred.	No polishing marks on tungsten particles or binder. Both have been attacked. Tungsten particles are standing proud of binder.
UK(Cu) 12 month exposure (Fig. 12)	A few polishing marks still on tungsten particles but there has been tungsten surface attack. Binder has been attacked and tungsten particles could be standing proud of it.	Appear to have more polishing marks than under O-ring, and holes between tungsten particles.	Extensive attack on both tungsten particles and binder. Tungsten particles standing proud of binder.

FIG. 10 SEM micrographs of the surface of the tungsten alloy UK(Fe) after full immersion in sodium chloride solution for twelve months in the presence of crevices.

(a)	LHS of micrograph, area under the O-ring; immediately adjacent to O-ring.	RHS, area
(b)	Inset, area under the O-ring. Area some distance from O-ring.	(x360) (x360)
